WATERWALL CORROSION PREVENTION EXPERIENCE AT THE COMMERCE REFUSE TO ENERGY FACILITY

JOE SMISKO

Commerce Refuse to Energy Facility
Commerce, California

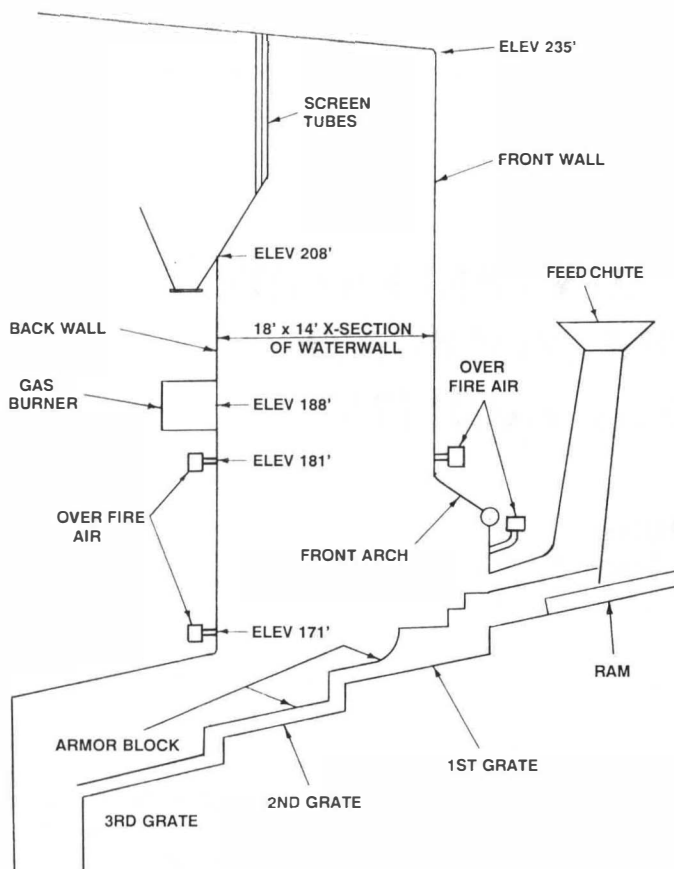
FIG. 1 COMMERCE REFUSE TO ENERGY FACILITY

The cross section of the furnace is shown in Figure 1. The waterwalls are 3 inch diameter \times 0.203 inch wall
